# Status of FE-B Flex2 Module Testing

*K. Einsweiler, LBNL*

## Status of IZM FE-B Module assembled with Flex2:

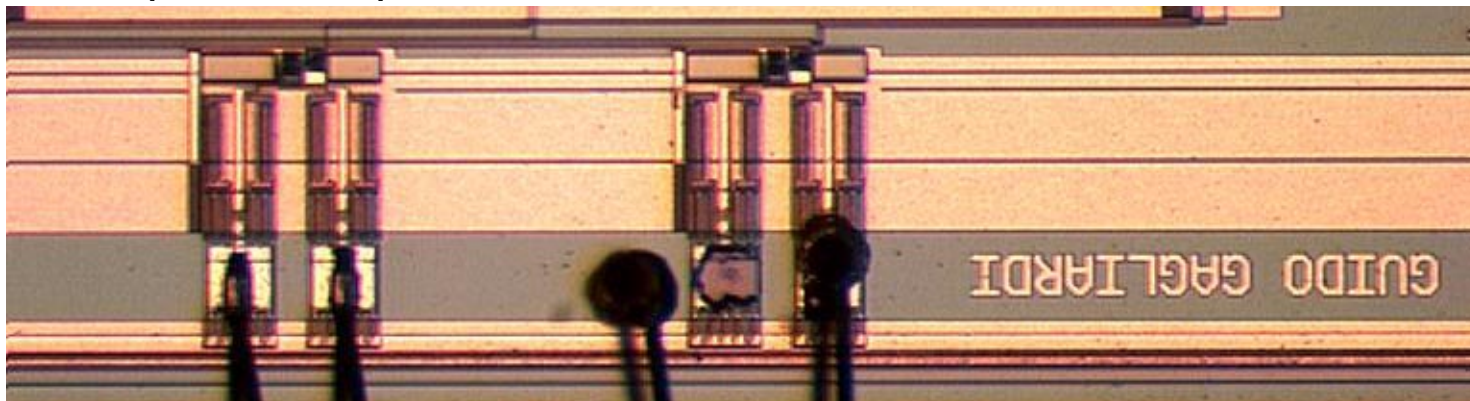
- Wire bonding proceeded relatively well, but there were a modest number of adhesion problems on Flex and on FE chips. Used combination of semi-automatic Al wedge bonder and manual gold ball bonder to make all bonds.

- One MCC pad which pulled off from the die:

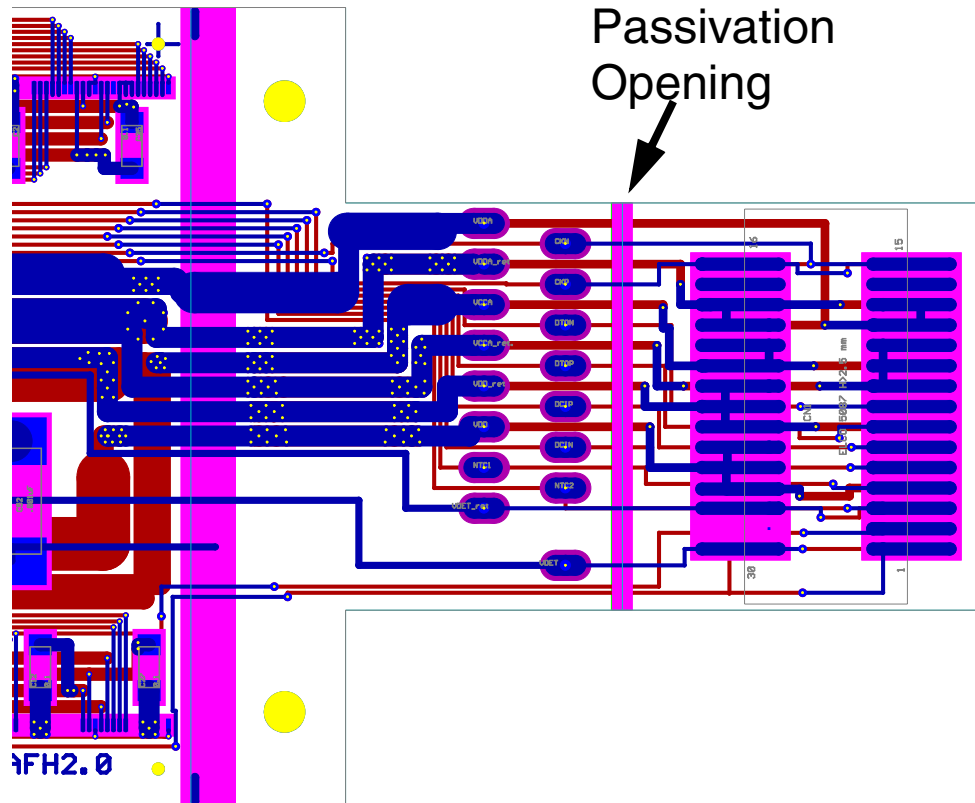
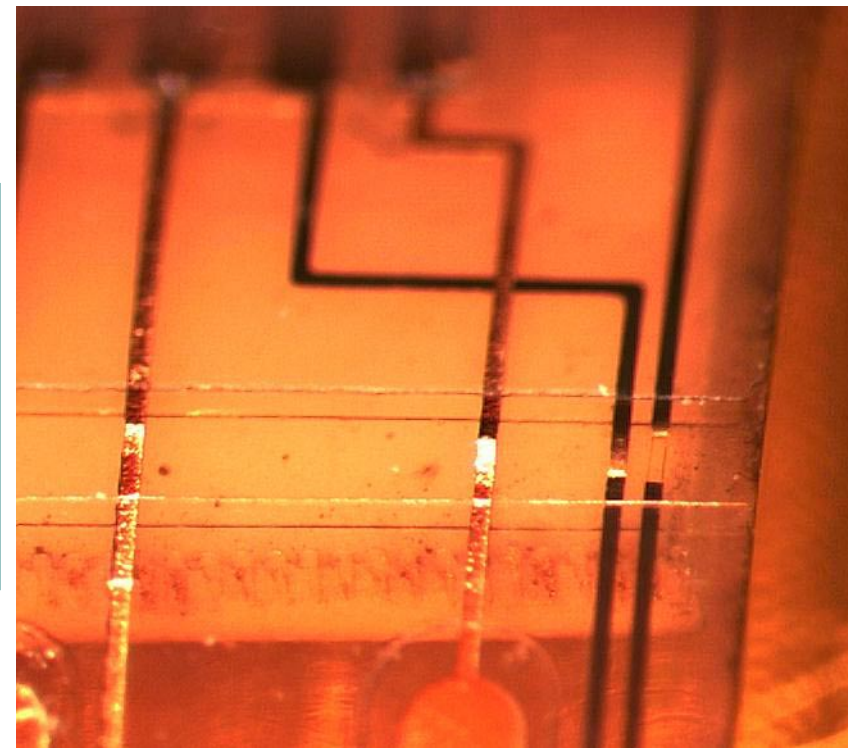
- Module was tested while still on vacuum chuck used for wire-bonding, using Mini-Support/Jumper system shown earlier. Clearly significant problems, even with power distribution.
- Visual inspection indicated that almost all traces in cut region between disk pigtail solder pads and test connector solder pads were broken. This part was handled by many people during assembly and it is not possible to be sure when the damage occurred. Inspection of cut, but not loaded, Flex showed signs of micro-cracks in some traces in this region also.

- Three cut regions on Flex2. Two have top-side openings in the coverlay only, because all traces have been routed to the Flex2 top side. The third, for removing the test connector, has coverlay openings on both sides since there are traces on both sides.

- The 25 $\mu$  Kapton substrate, without coverlay protection, makes the Flex incredibly fragile (it is not really a Flex at all, since it does not use annealed Copper...). Very special handling is required (see talk of Maurice).

- Further believe that the coverlay openings are not necessary, even for the test connector. Careful routing of traces to insure no superposition of traces on opposite sides would allow cutting without danger of shorts from trace fragments.

- For now, the module has been mounted on a prototype sector using our usual CGL7018 and NEA123 glue protocol. The ceramic stiffener under the Elco connector has also been tacked to the Carbon-Carbon using NEA123. This completely immobilizes the Flex in the region of the broken traces, and will permit hand repair, by connecting small wires from Elco solder pads to pigtail solder pads. Traces on Flex passing through the other cut regions seem to be intact.
